KAHLE LAKE DAM

NDI No. PA 00825
PennDER No. 61-20

PHASE I INSPECTION REPORT
NATIONAL DAM INSPECTION PROGRAM

AUGUST 1979

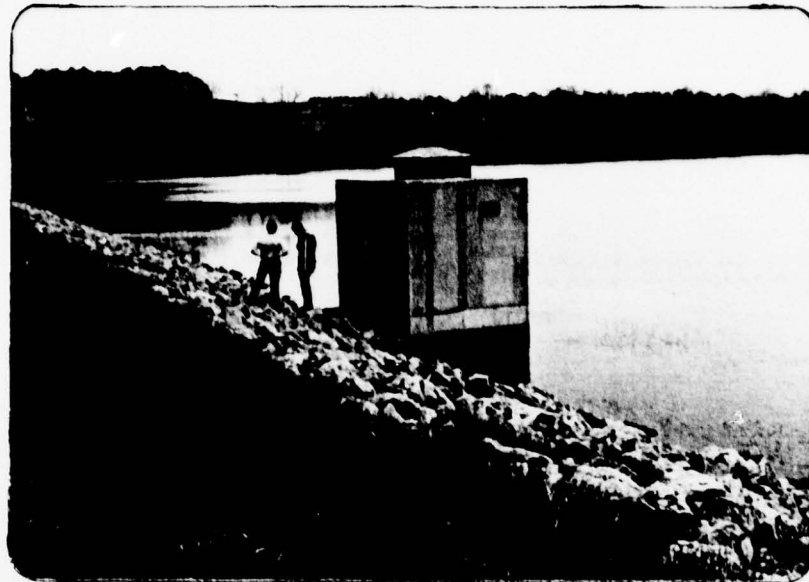
PHOTO 1. Control Tower on Upstream Slope

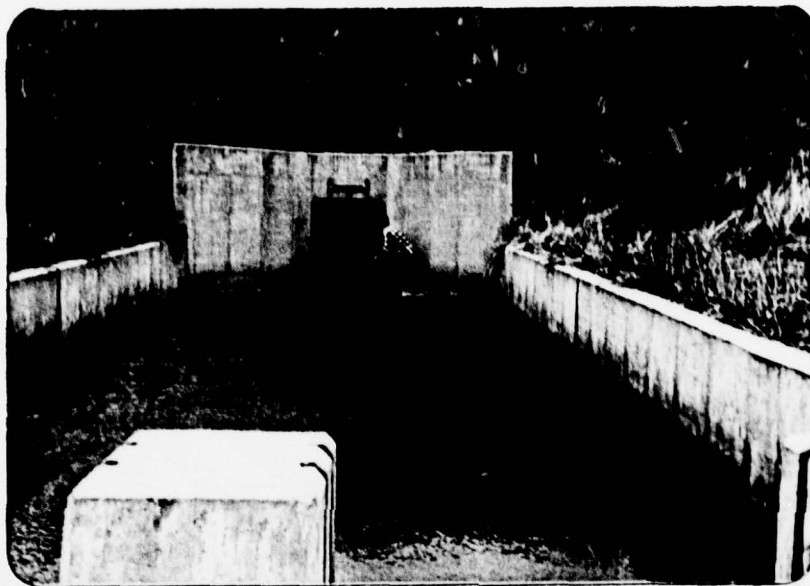
- c. Appurtenant Structures - A few minor cracks were noted along the walls of the outlet discharge basin of the principal spillway. Also, a small ditch was noted to the right of the outlet channel undercutting the riprap.

PHOTO 3. Outlet of Principal Spillway (Outlet Discharge Basin)

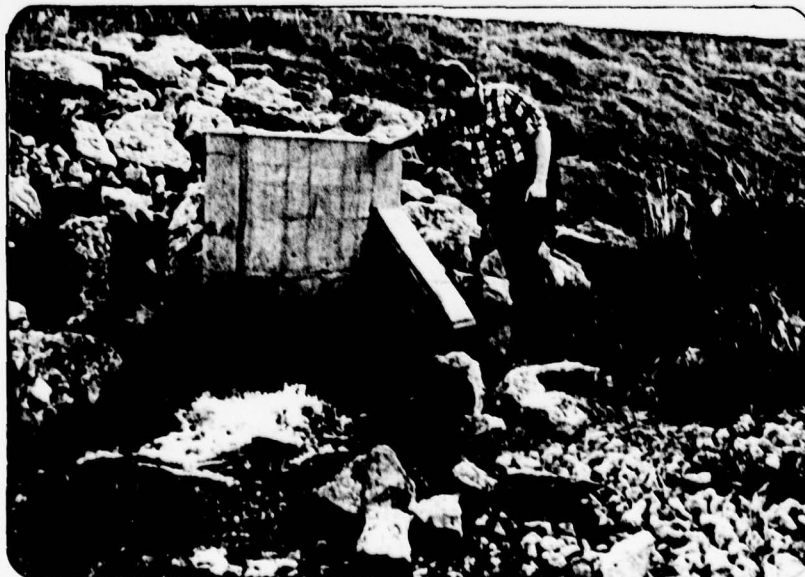
PHOTO 6. Head Wall for 12 inch A.C.C.M.P. from Stilling Basin

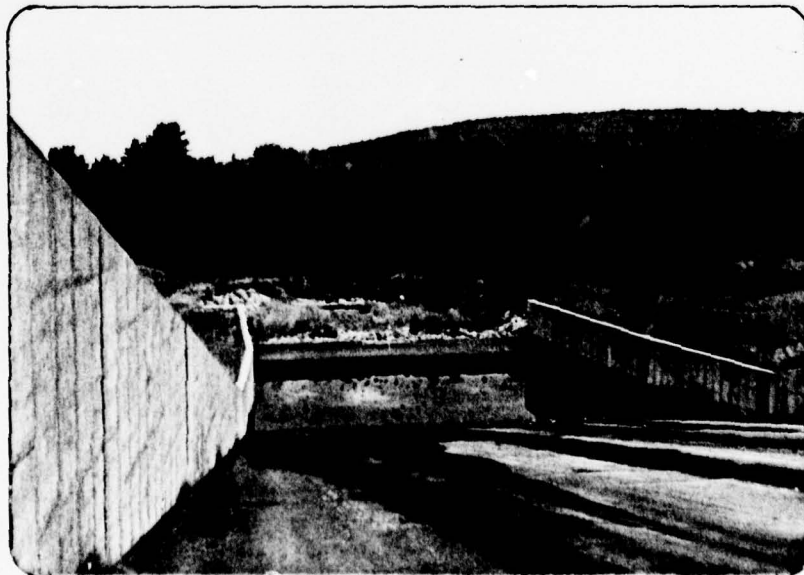
PHOTO 8. View of Stilling Basin and Concrete Chute Looking Downstream
